**CONDITION ASSESSMENT OF BUILDINGS
FOR
REPAIR AND UPGRADING**

Building Inspected Address:
Dhanalakshmi Flats
No.28.Vegavathy Street, Rajaji Nagar,
Villivakkam, Chennai -600 049

Submitted to:
Mr.K.G.Janakiraman
Managing Director
Jayaswathy Constructions (P) Ltd.,
No.36.Kaveri Street, Rajaji Nagar, Villivakkam,
Chennai – 600 049

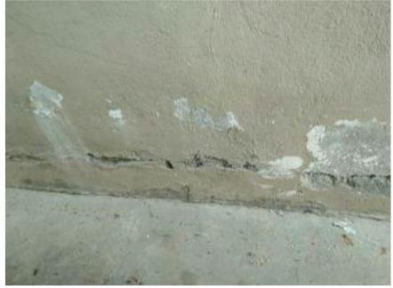
2

<p>Findings: No settlement Noticed at site. But horizontal cracks noticed. This may be due to corner settlement of column.</p> <p>Reason: This may be due to corner settlement of column.</p>
3

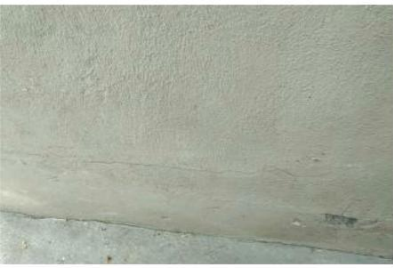
<p>Findings: No settlement noticed</p>
4

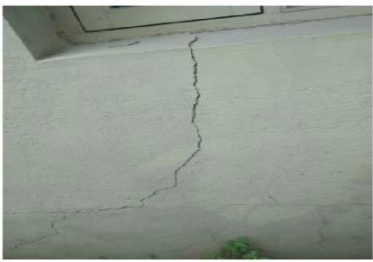
<p>Findings: Vertical cracks noticed in the window centre on both side of wall on the corner window only. Other windows no cracks not there.</p> <p>Reason: Corner column settlement, due to which it started giving open in the window bottom.</p>
5

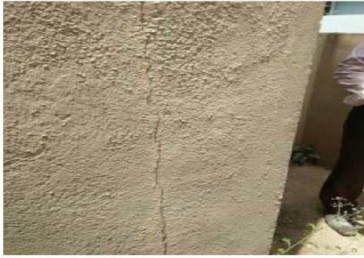
<p>Findings: Vertical separation cracks noticed between column and wall. But the Crack width is less and repairable.</p> <p>Reason: This is only due to corner column settlement.</p>
6

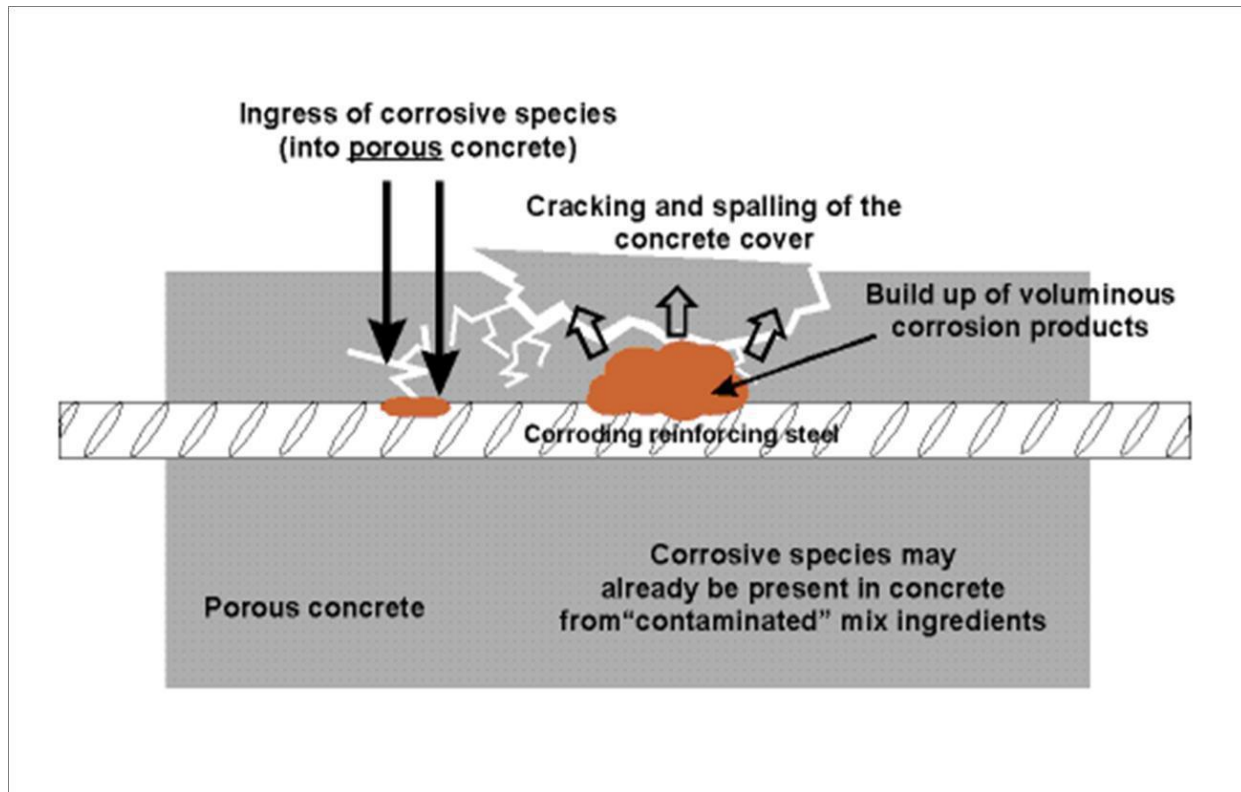
No corrosion of rods noticed except in column in the south west corner and the suggested treatment to be done during repair. But the building repair needs to be periodically checked and repaired once in 5years regularly to increase the life of the structure.

Corrosion due to reinforcement is shown below.
