## RESIDENTIAL BUILDING INSPECTION REPORT

**Residential Building Inspection  
For  
Assessing the cause of tilting of building  
Owned by  
Mrs.Samundeeswari & .Krishnamoorthy.,  
And Insured with  
United India Insurance Co. Ltd.**

**Date of Inspection: 28.06.2016**

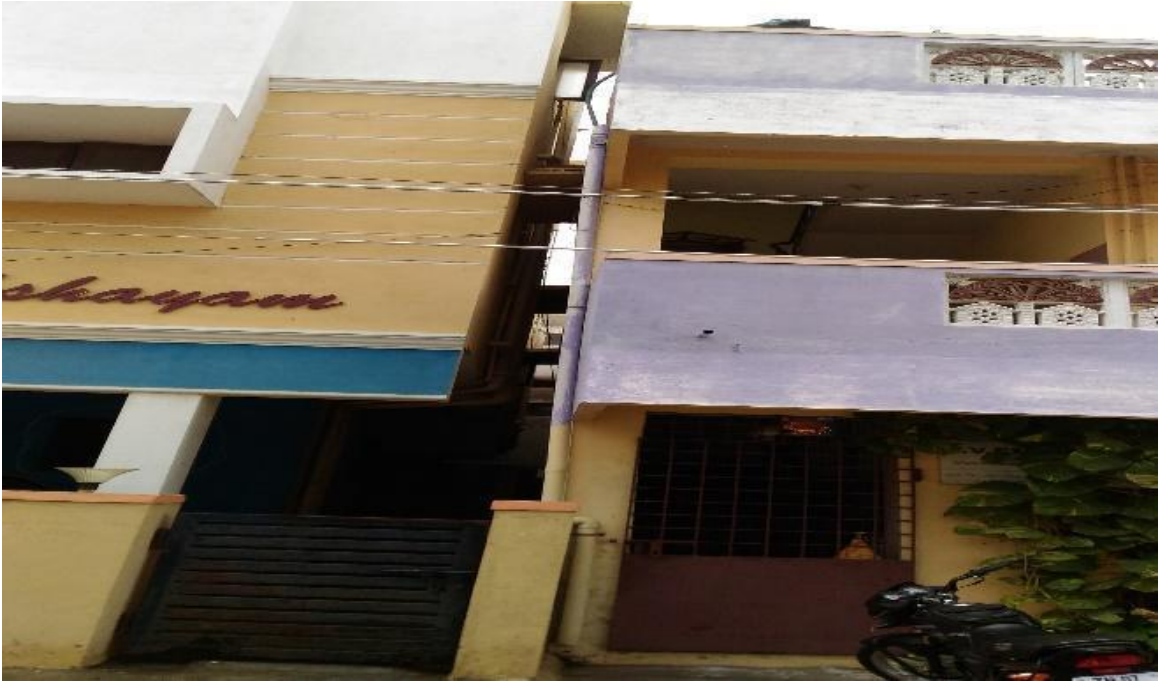
- The Residential building is south facing Building and was found tilted on one side by 15 to 20 degree on western side and the sunshade rested on the nearby building. On west side length of the building tilted from the centre of the building to northwest building corner to the neighbouring building. There are no visible cracks on the tilted portion of the building side except near the sunshade area and rear side column and **wall pulling the building to west side.**

**Building tilting on western side of the plot. -1**

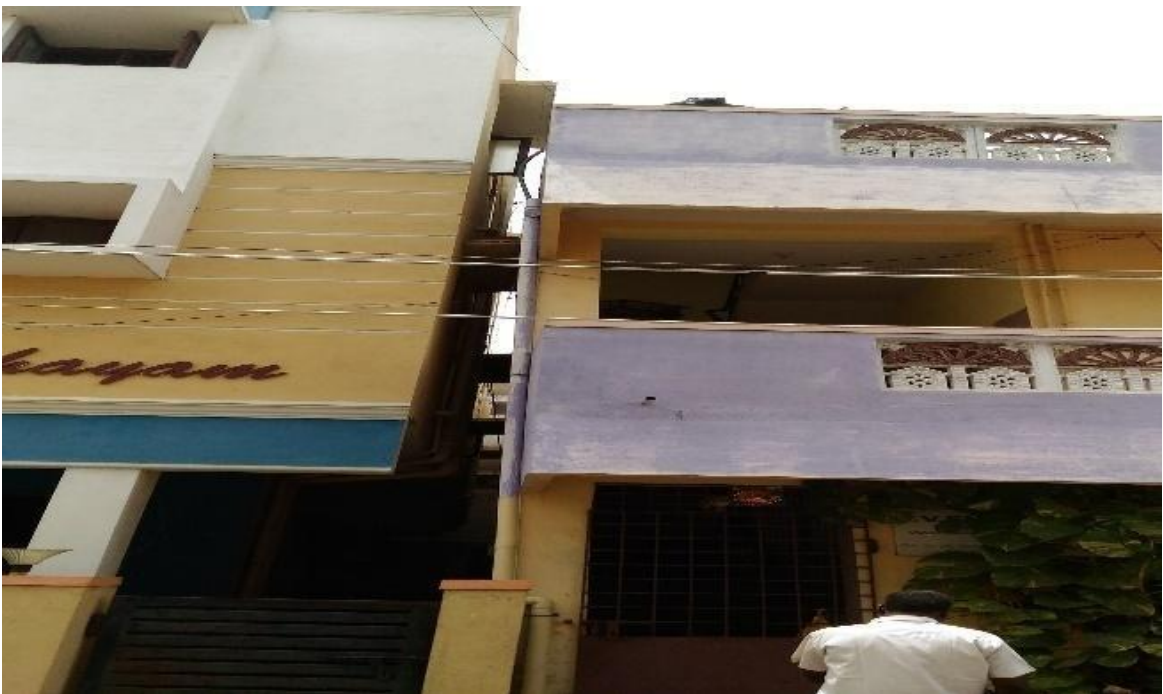
**Building tilting on western side of the plot. -2**

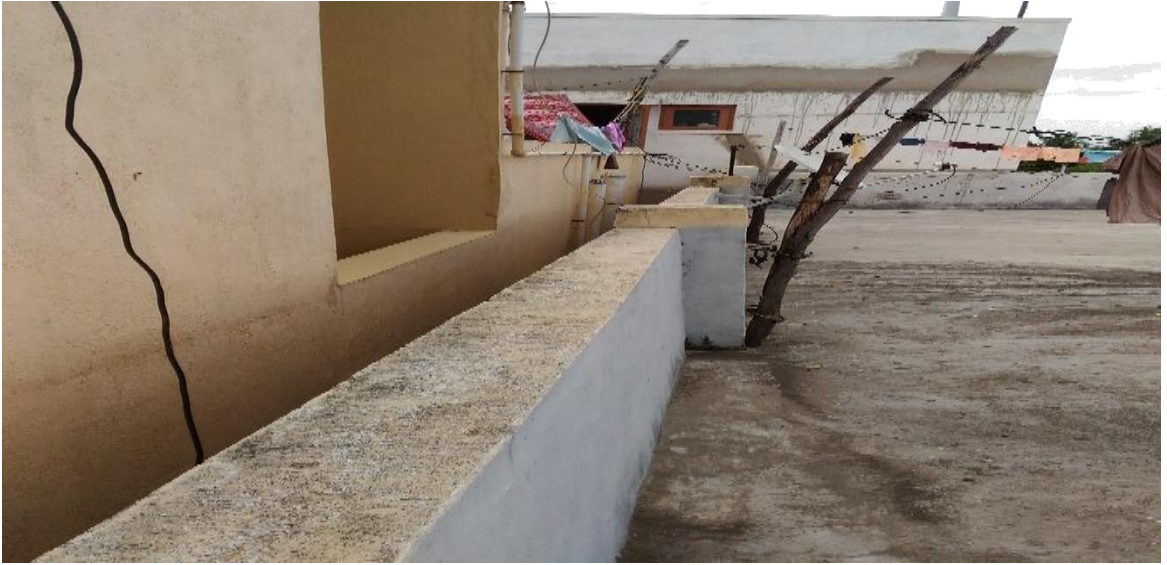
**Photo showing the tilt in terrace floor -1**

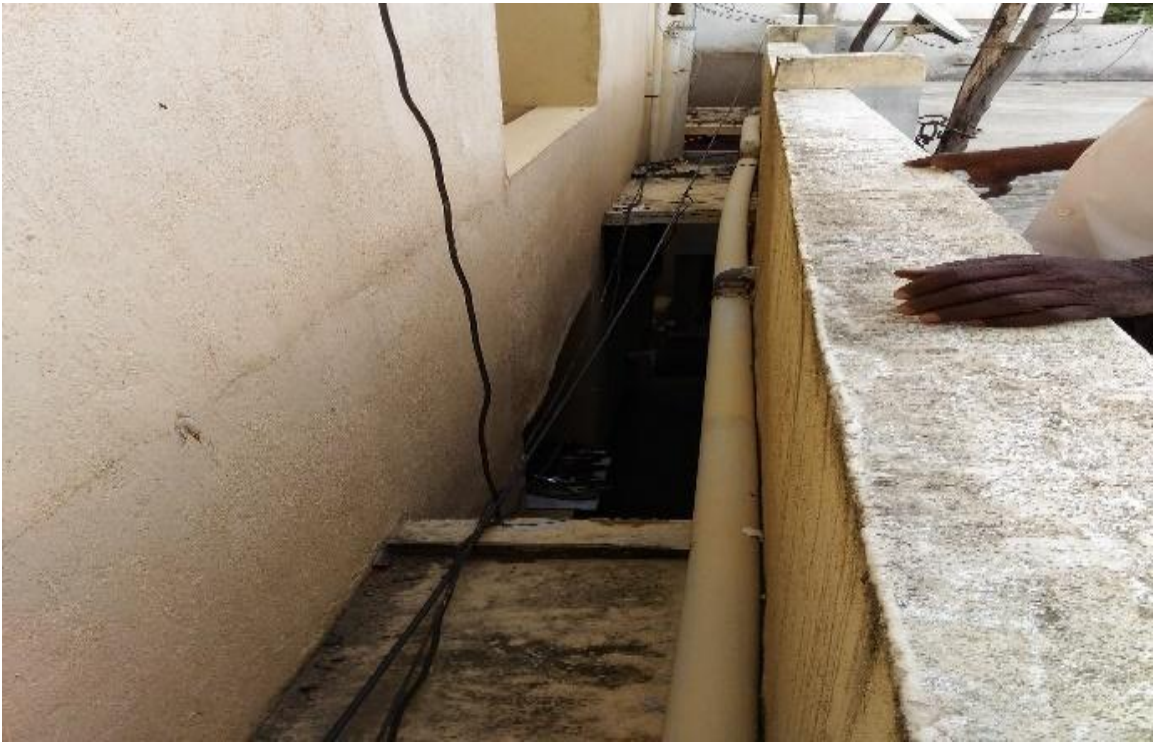
**Photo showing the tilt in terrace floor -2**

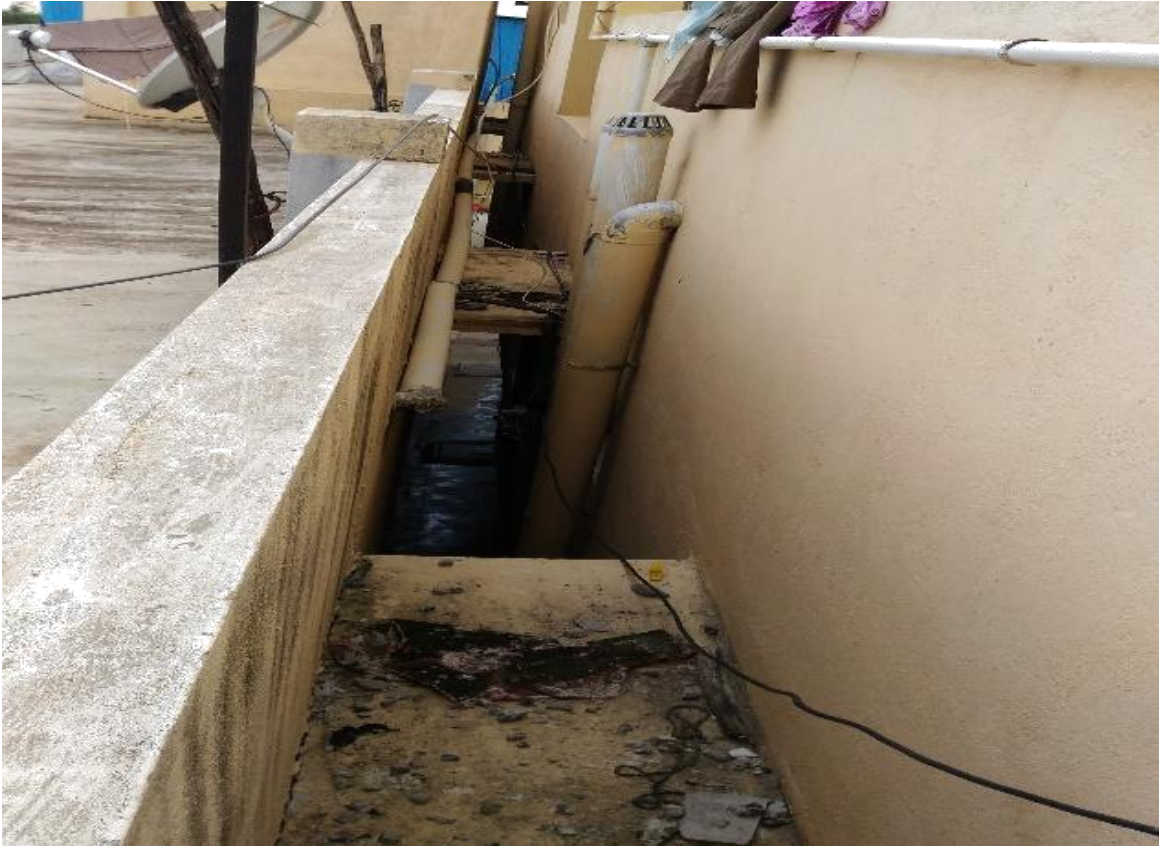
**Photo showing in between the building - 1**

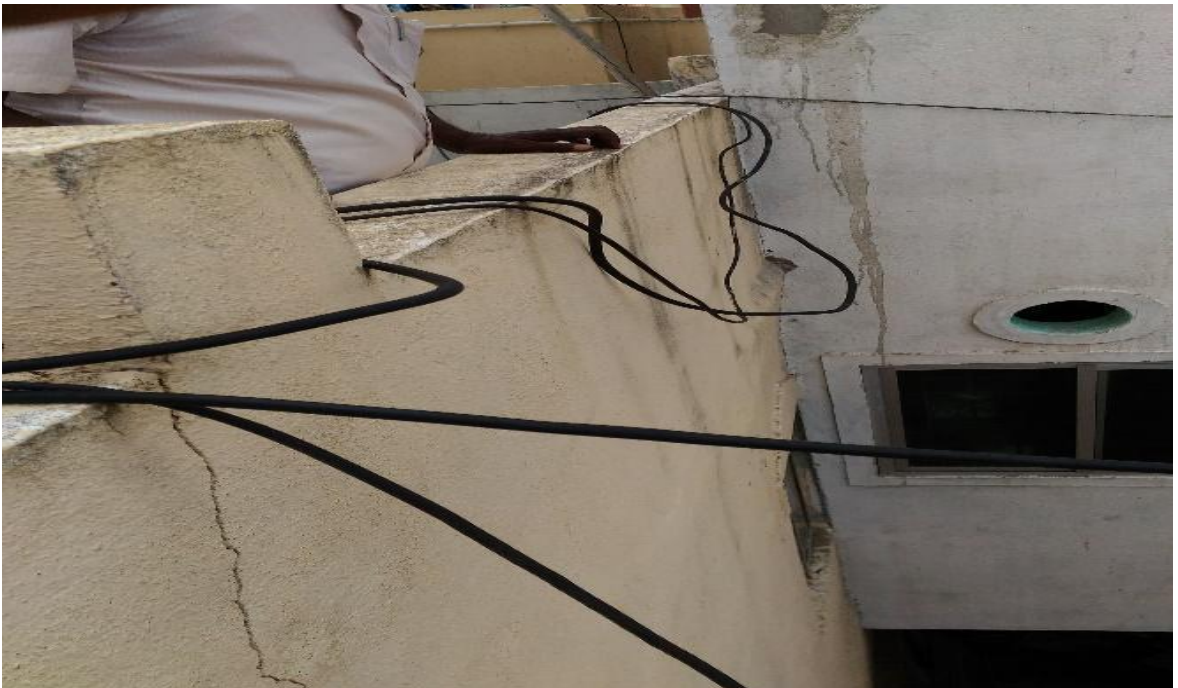
**Photo showing on the North side of the building**

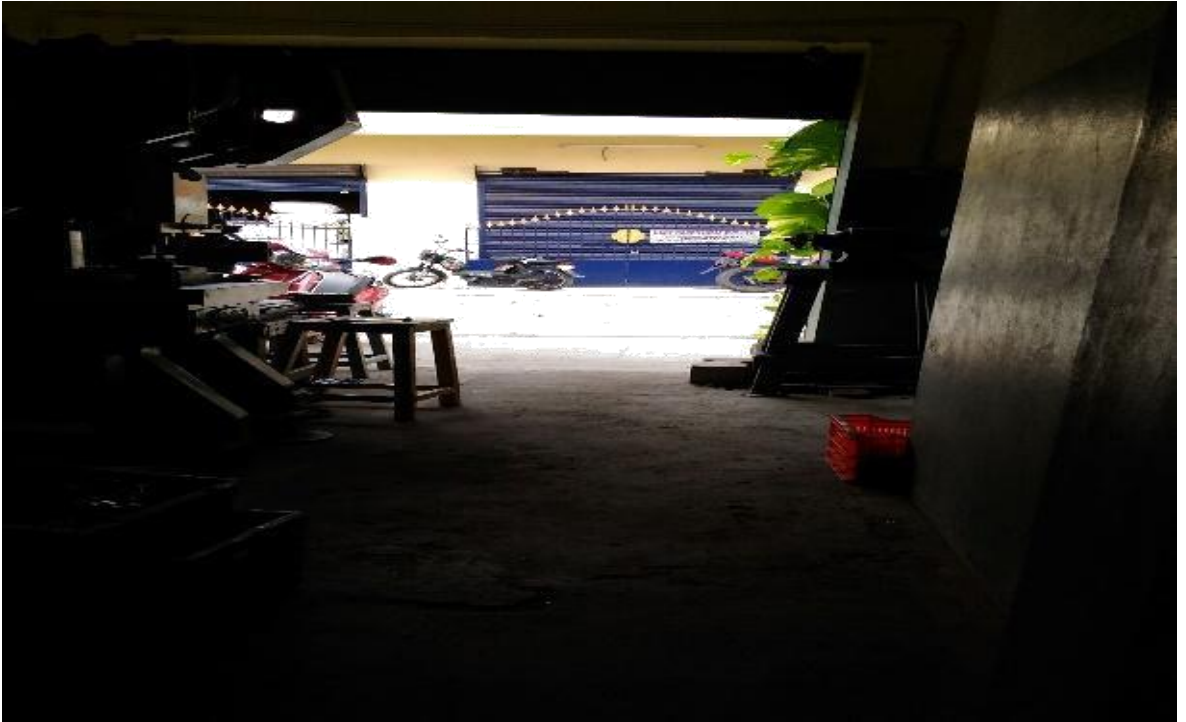
**Photo showing the lath machine room**

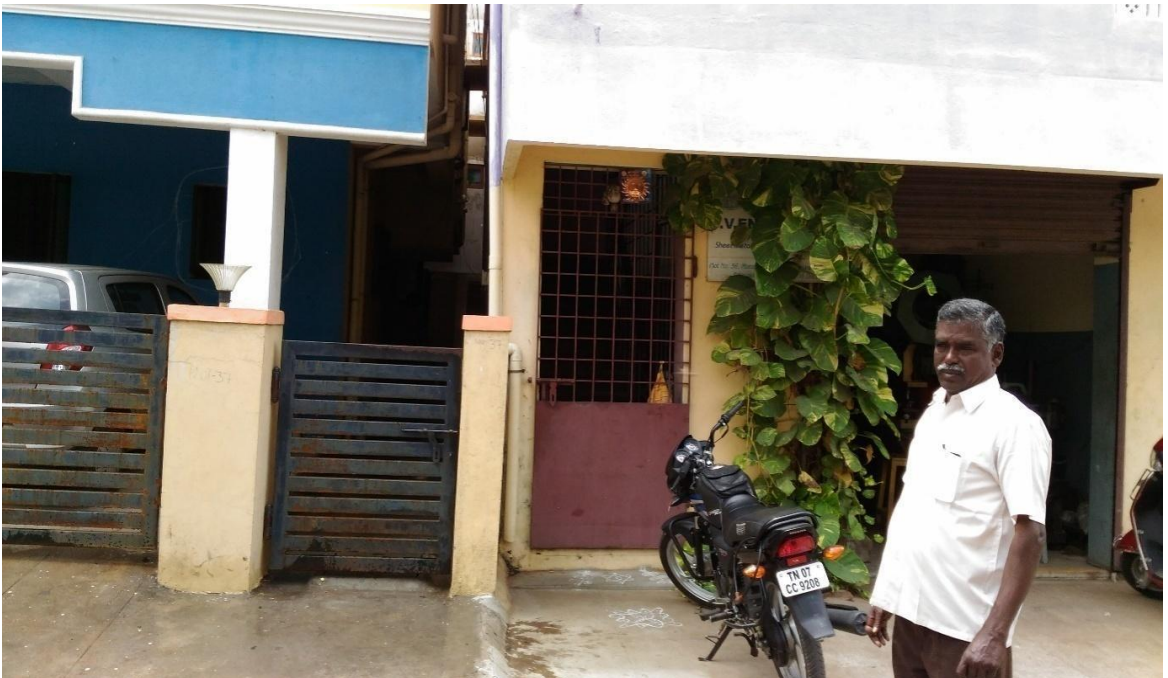
**Front portion of the Building**
