**CONDITION ASSESSMENT OF BUILDINGS
FOR
REPAIR AND UPGRADING**

Building Inspected Address:
Dhanalakshmi Flats
No.28.Vegavathy Street, Rajaji Nagar,
Villivakkam, Chennai -600 049

Submitted to:
Mr.K.G.Janakiraman
Managing Director
Jayaswathy Constructions (P) Ltd.,
No.36.Kaveri Street, Rajaji Nagar, Villivakkam,
Chennai – 600 049

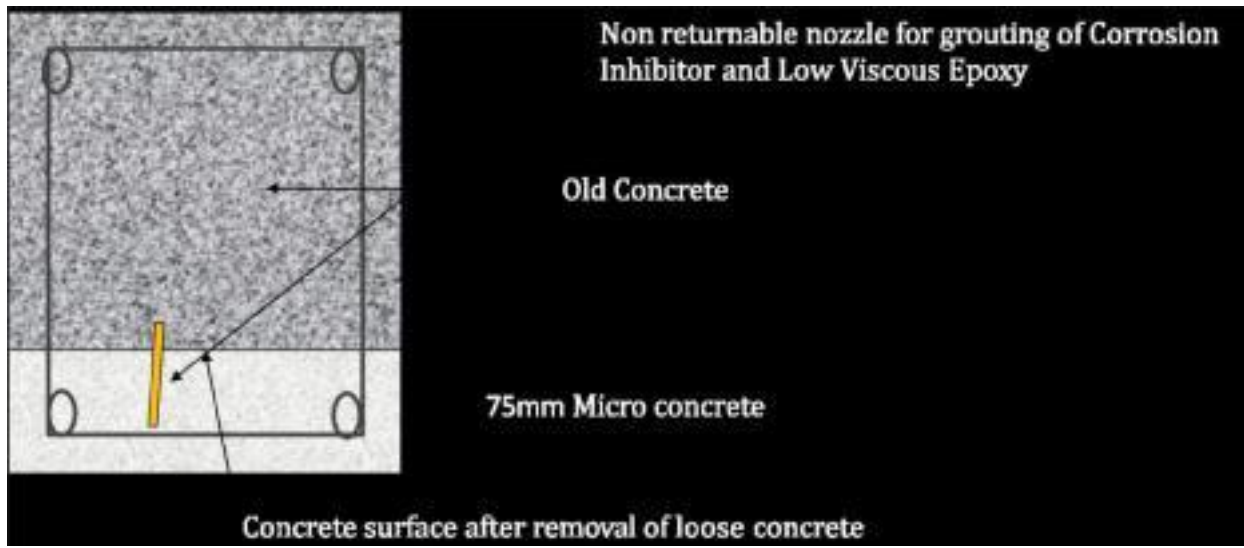
REPAIRS TO COLUMNS

In case the distress at the location is restricted to single face no jacketing will be required. Repair be carried out as given in sketch

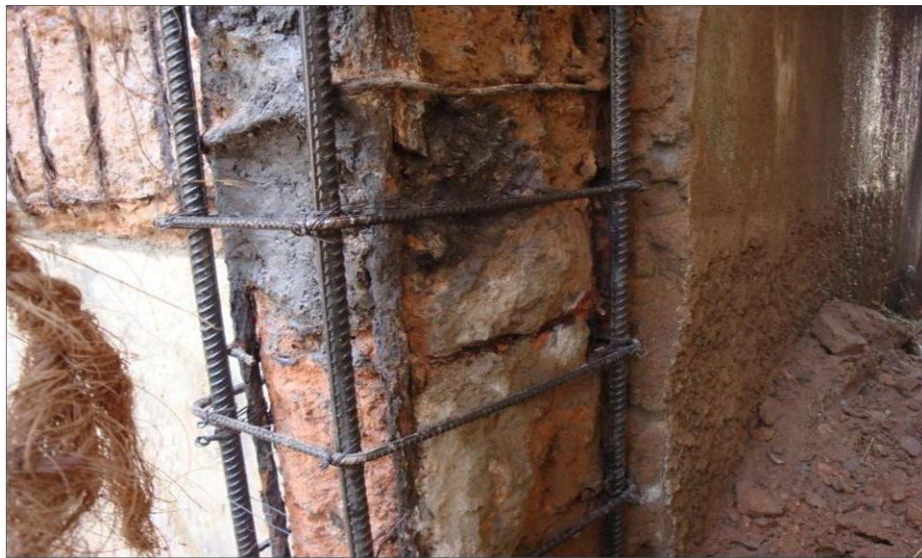
JACKETING OF COLUMNS

If the distress is more than on face of a column and reinforcement is corroded less than 20% no new reinforcement is needed only Jacketing is required.

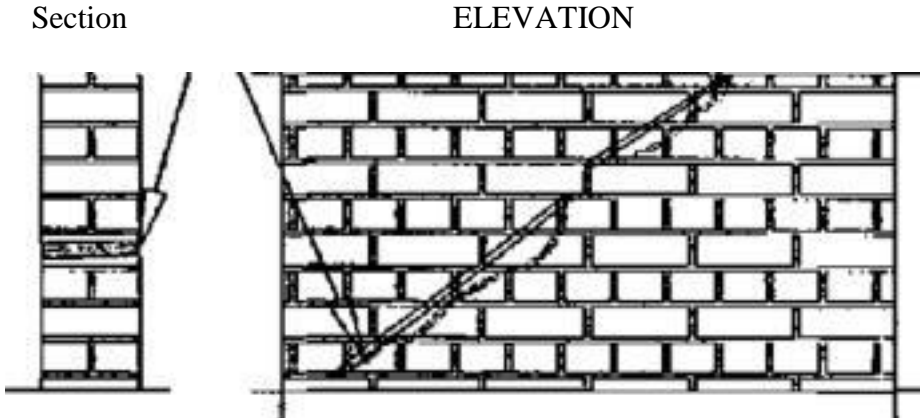
Cement mortar and flat-stone chips placed as filler in wide cracks

(g) To prevent widening of the cracks they can be stitched
